Manhole Inspection Summary

Manhole # S35KK_010MH

Location Address: **1822 BARCLAY ST**

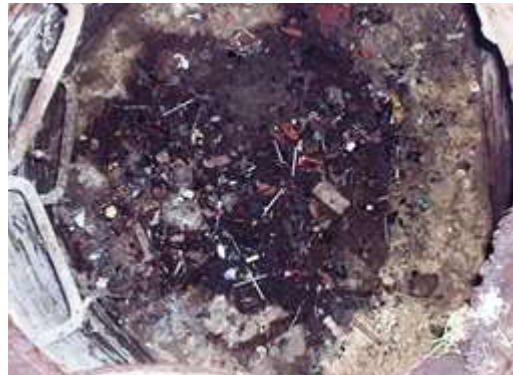
Top View

Channel debris.

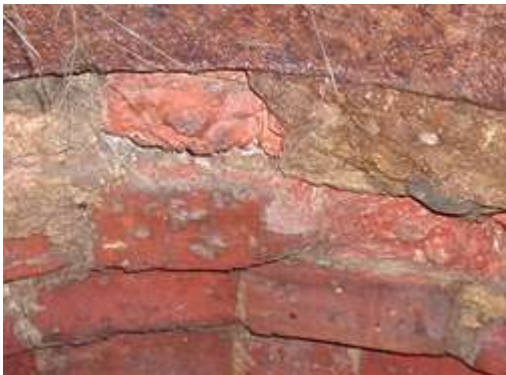
Defect

Adjustment deterioration and infiltration.
Corbel infiltration - other side.

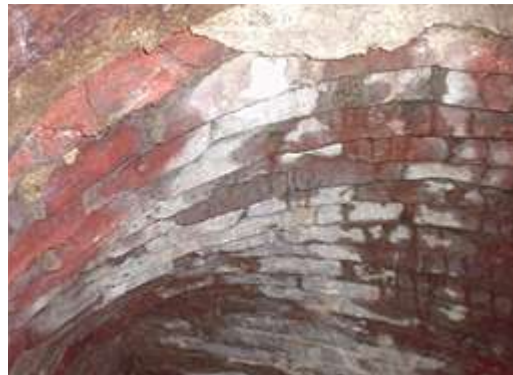
Defect

Adjustment deterioration and infiltration.
Corbel infiltration.

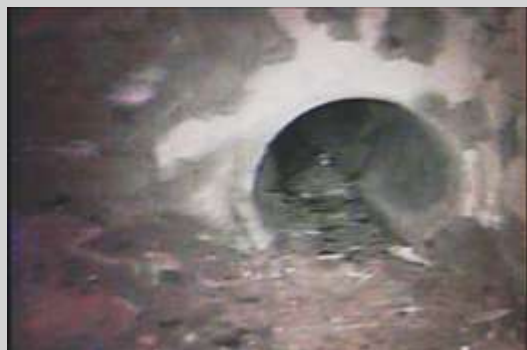
Pipe Out @ 12 O'Clock

Deposits: ☐ None ☒ **Mud** ☐ Sludge ☒ **Debris** ☐ Grease

Silt Depth: **0.5** (in.)

Deposits Extent: **Light**

Infiltration: **Evidence**
